American Competitiveness Institute

JGPP / JCAA LEAD FREE SOLDERING PROGRAM
Salt Atmosphere, Temperature Humidity, and
Mechanical Shock Testing Results
February 9, 2006

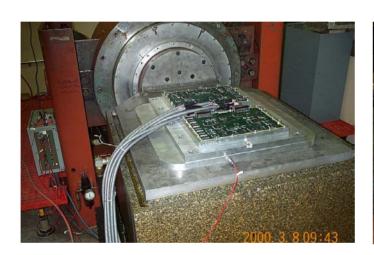
Equipment Set-up

Ling Electronics B335 Vibration Systems
Courtesy of BAE Systems, Lansdale, Pennsylvania

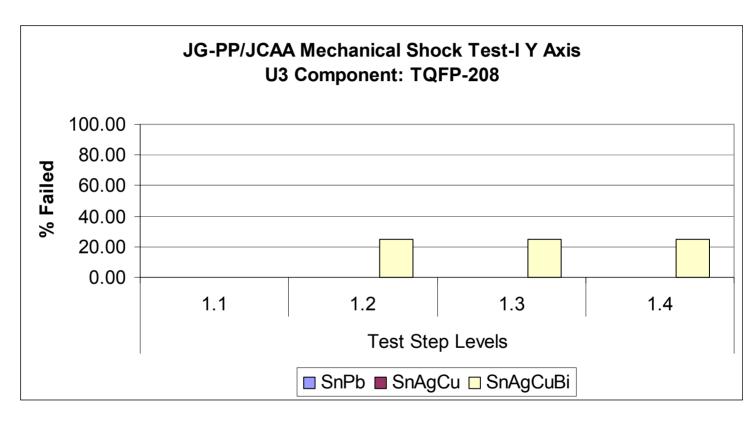
Intermittent Failures Found at Level 1.4

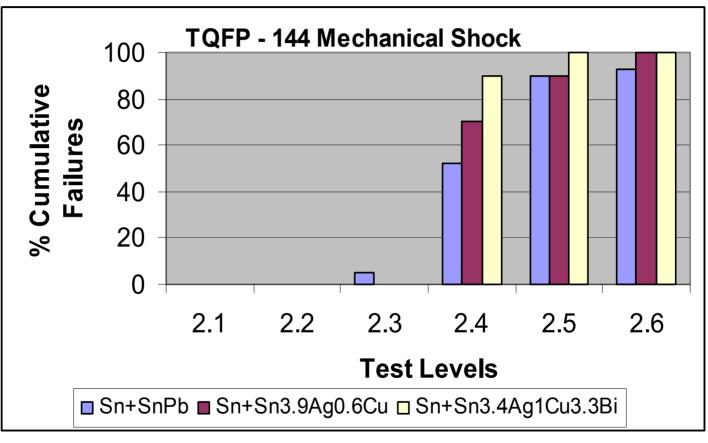
Intermittent SnPb Failures Found at Level 2.6 (40%)

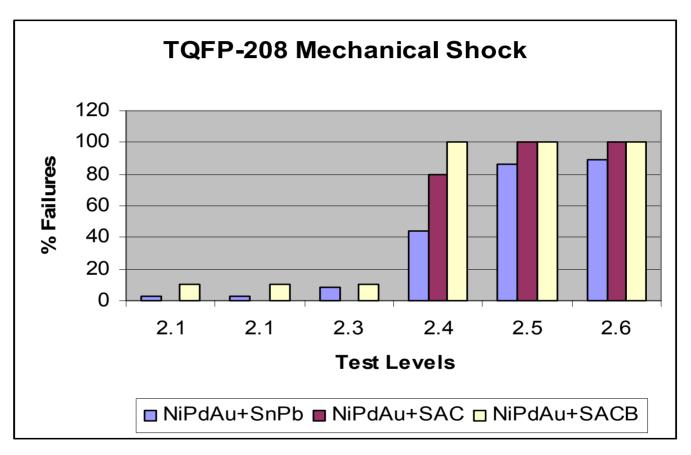
Intermittent SnPb Failures Found at Level 2.6 (52.5%)

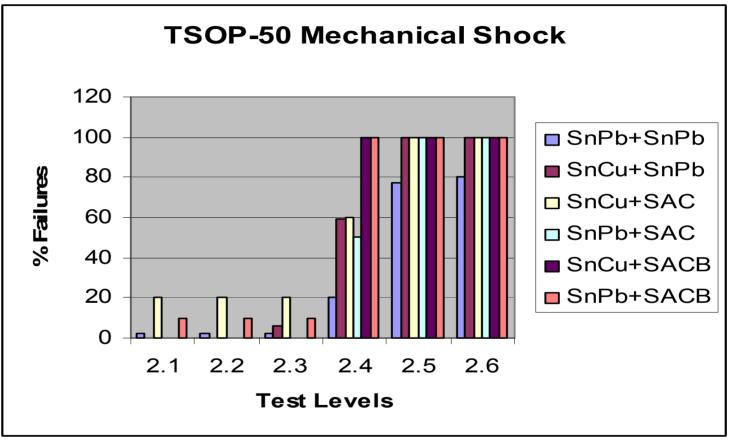
Intermittent SnPb Failures Found at Level 2.6 (50%)

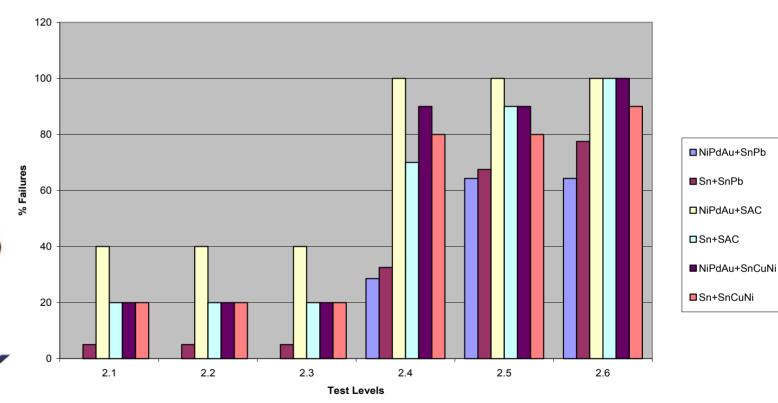
Component PDIP-20 Failures

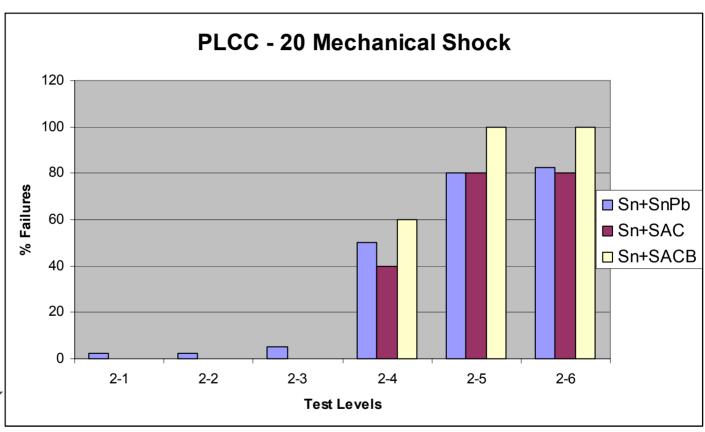
Intermittent SnPb Failures Found at Level 2.6 (35%)

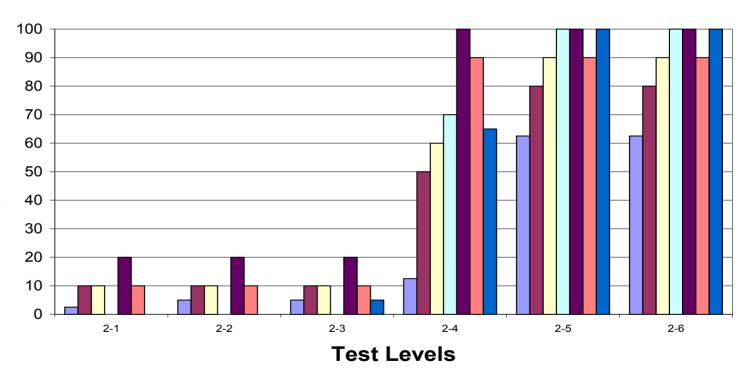
JCAA / JG-PP Mechanical Shock Test-II Component: CLCC-20

Intermittent SnPb Failures Found at Level 2.6 (45%)

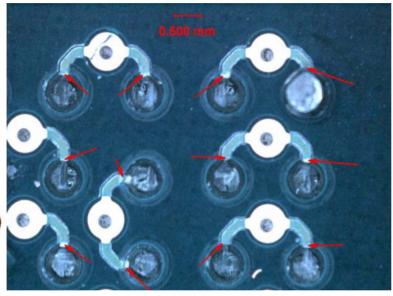
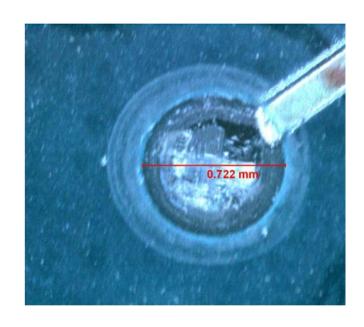
BGA -225 Failures

Top down view of board
Top Right hand Corner Area of a BGA

BGA Ball Solder Pad

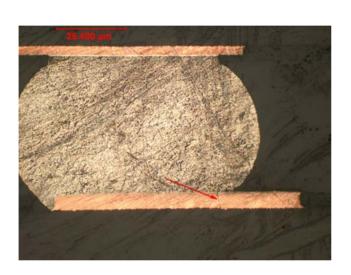
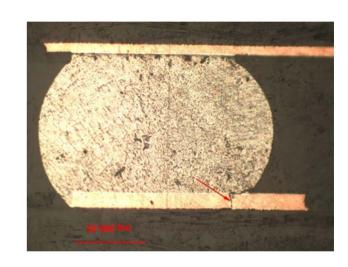
SnAgCu/SnAgCu, BGA U44, PCB trace failure at BGA Ball This type of failures could cause intermittent electrical failures

- Salt Atmosphere Test: Found No failures
 - SnPb, SnAgCu and SnAgCuBi considered equivalent
- Temperature Humidity Test: Found No failures
 - SnPb, SnAgCu and SnAgCuBi considered equivalent
- Mechanical Shock Test I
 - SnPb and SnAgCu passes test
 - SnAgCuBi had specific component failures (FMA needed)
- Mechanical Shock Test II
 - Overall SnPb boards outperformed SnAgCu and SnAgCuBi
 - Detailed FMA is needed to provide solder comparison
 - Limited FMA on BGA devices indicate copper traces are primary cause of failure

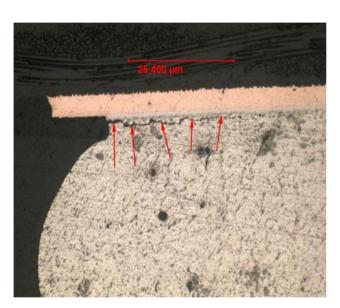
SnPb MANUFACTURED, BGA U44,..

SnAgCu/SnAgCu, BGA

Solder Ball crack on the Component side, No failures of this type found but small amount of cracking seen
